DELAWARE RIVER BASIN
DOCTORS CREEK MONMOUTH COUNTY
NEW JERSEY

ALLENTOWN DAM NJ 00308

PHASE 1 INSPECTION REPORT NATIONAL DAM SAFETY PROGRAM

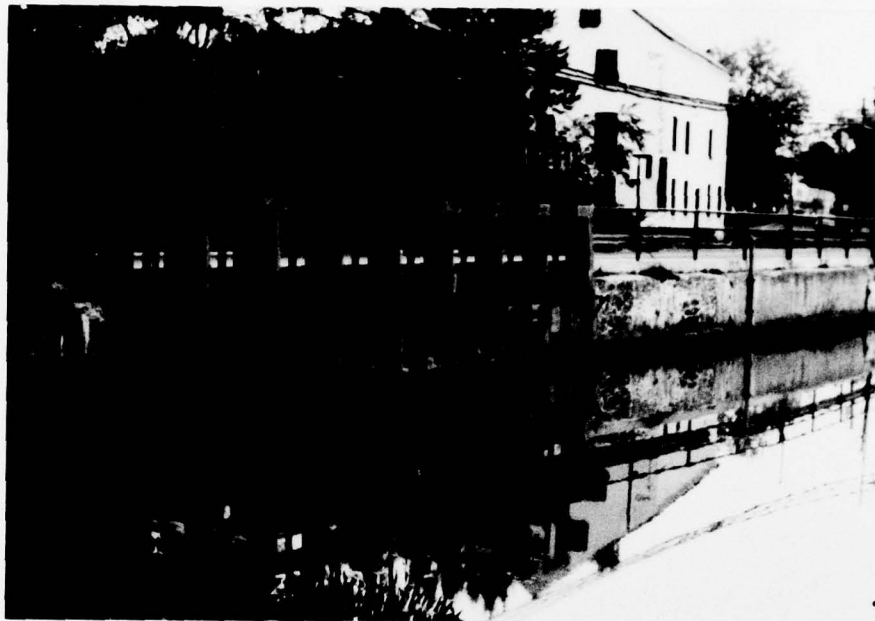
Photo No. 1 - Overall view of dam from upstream. The spillway and bridge structure are in the foreground. Note the spalled concrete at the water surface and the deteriorated timber gate supports.

1. Replace the old timber stop-planks with steel or concrete planks. Replace the timber slides and supports. This work to be completed in six months.
2. Provide concrete underpinning at the toe of the retaining walls where undermining has occurred. This work to be commenced within six months.

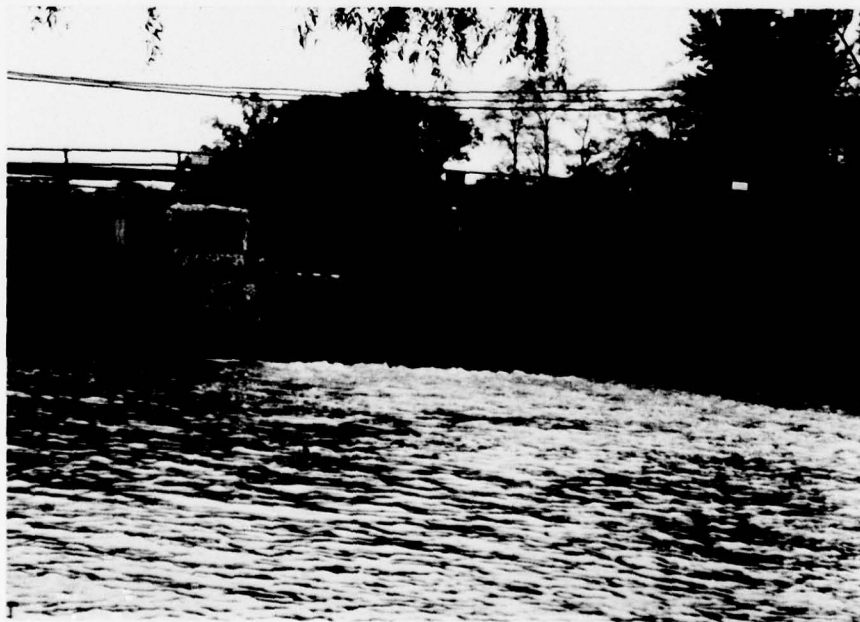
The spillway stop-planks showed signs of leakage around the sides, and through the planks themselves. Some of the planks appeared to be extensively rotted. The timber gates were all in good condition, but the slides and support posts are rotted. The original lakeside walkway has been removed, leaving only the brackets. The concrete frame and raker beams were in satisfactory condition. Debris had lodged on the stop-planks and behind the raker beams, but flow was not unduly restricted. The spillway apron surface was not visible due to the flow of water, but the horizontal alignment was satisfactory and no excessive turbulence to suggest deterioration was found. Undermining at the toe was minimal.

Photo No. 2 - View of spillway, apron and bridge from downstream. Leakage through stop-planks is extensive and concrete wall facing is spalled.

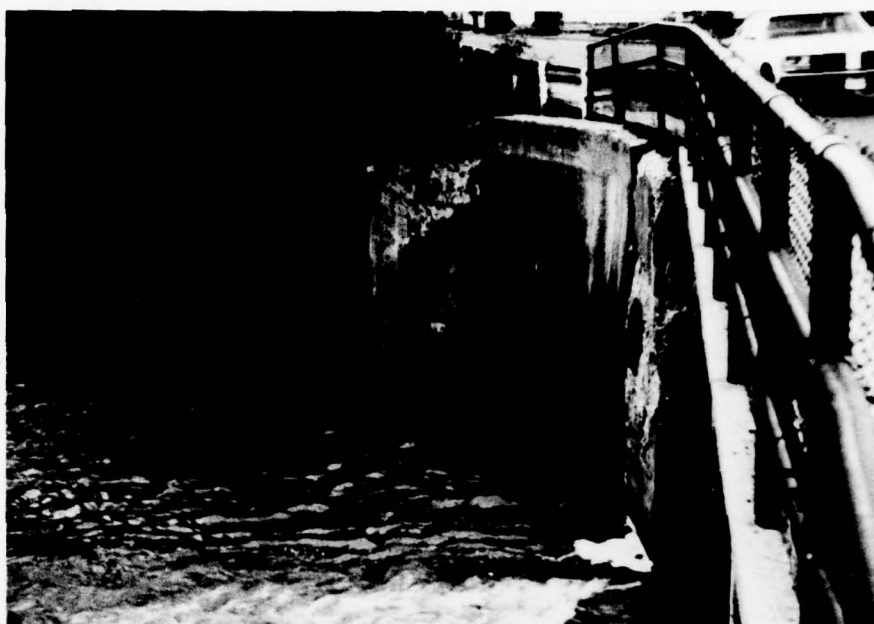
Photo No. 3 - Detail of right downstream retaining wall. Note the deteriorated concrete on the bridge abutment and retaining wall.

6. Repair spalled and cracked concrete and concrete facing, re-point all masonry as necessary within 12 months.
7. All brush and trees should be removed from the downstream slopes to avoid problems which may develop from their roots. The embankment should then be seeded to develop a growth of grass for surface erosion protection. This program should be started within 12 months.

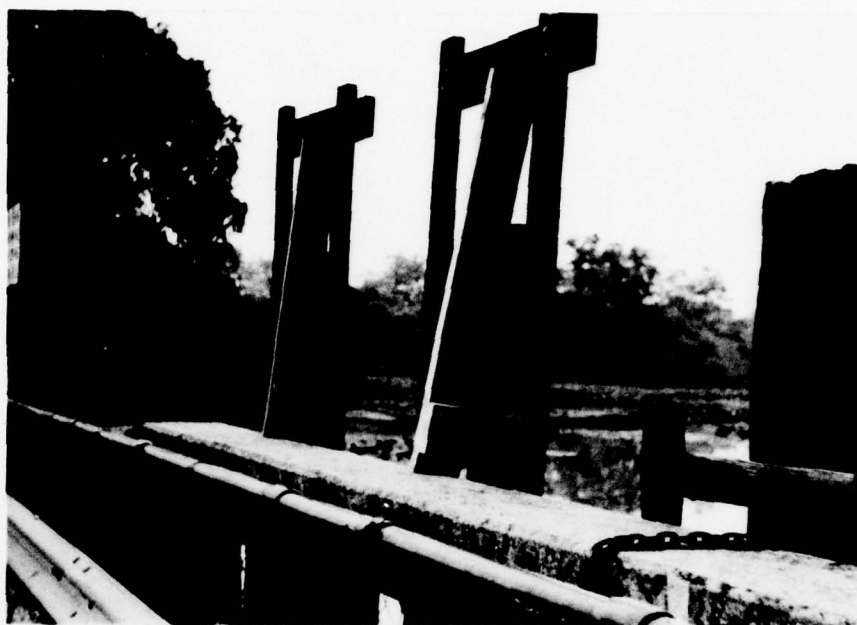
Photo No. 7 - Detail of support device for holding the timber gates open.

GATES & OPERATION EQUIPMENT	The upper 2 feet of stop-planks in each of the portals are designed to be moveable, and are fitted with timber lifting frames for manual operation. The gates have been recently renewed, but the slides and props are deteriorated. Only seven of the eight gates are operational. The two right-hand gates were propped open at the time of inspection, held by pinch-bars.	Replace timber slides and provide mechanical device for operation.

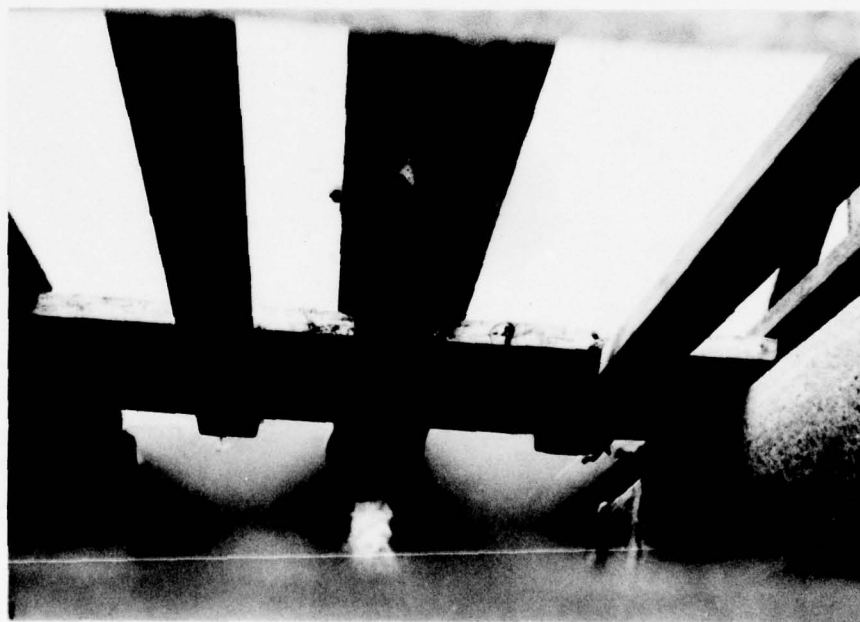
Photo No. 8 - Detail of open timber gate from above.

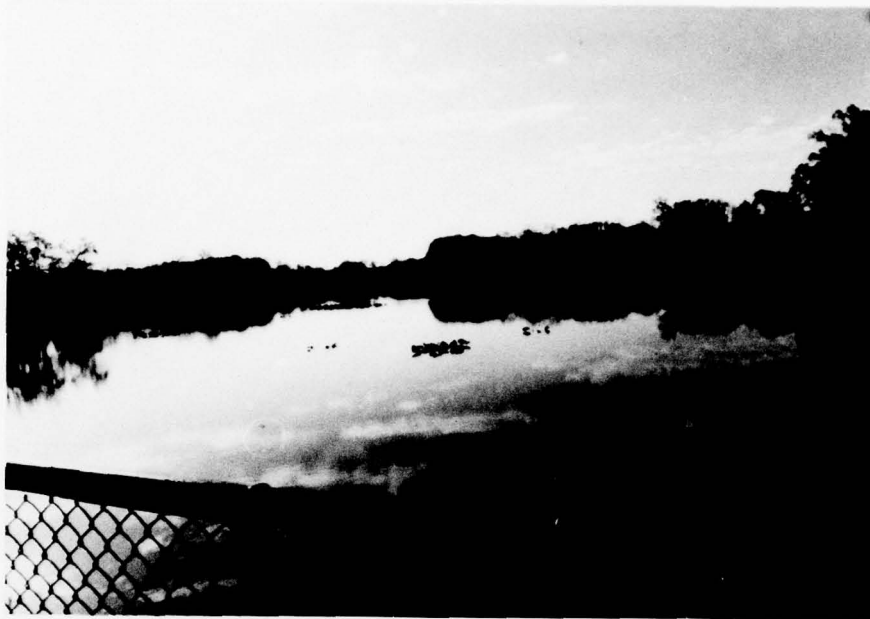
Photo No. 11 - View of the reservoir looking upstream from the bridge. Note moderate slopes and weed growth around rim.
